The Earth Rangers Centre

Practical improvements to achieve LEED Platinum EB:O+M

BY ANDY SCHONBERGER

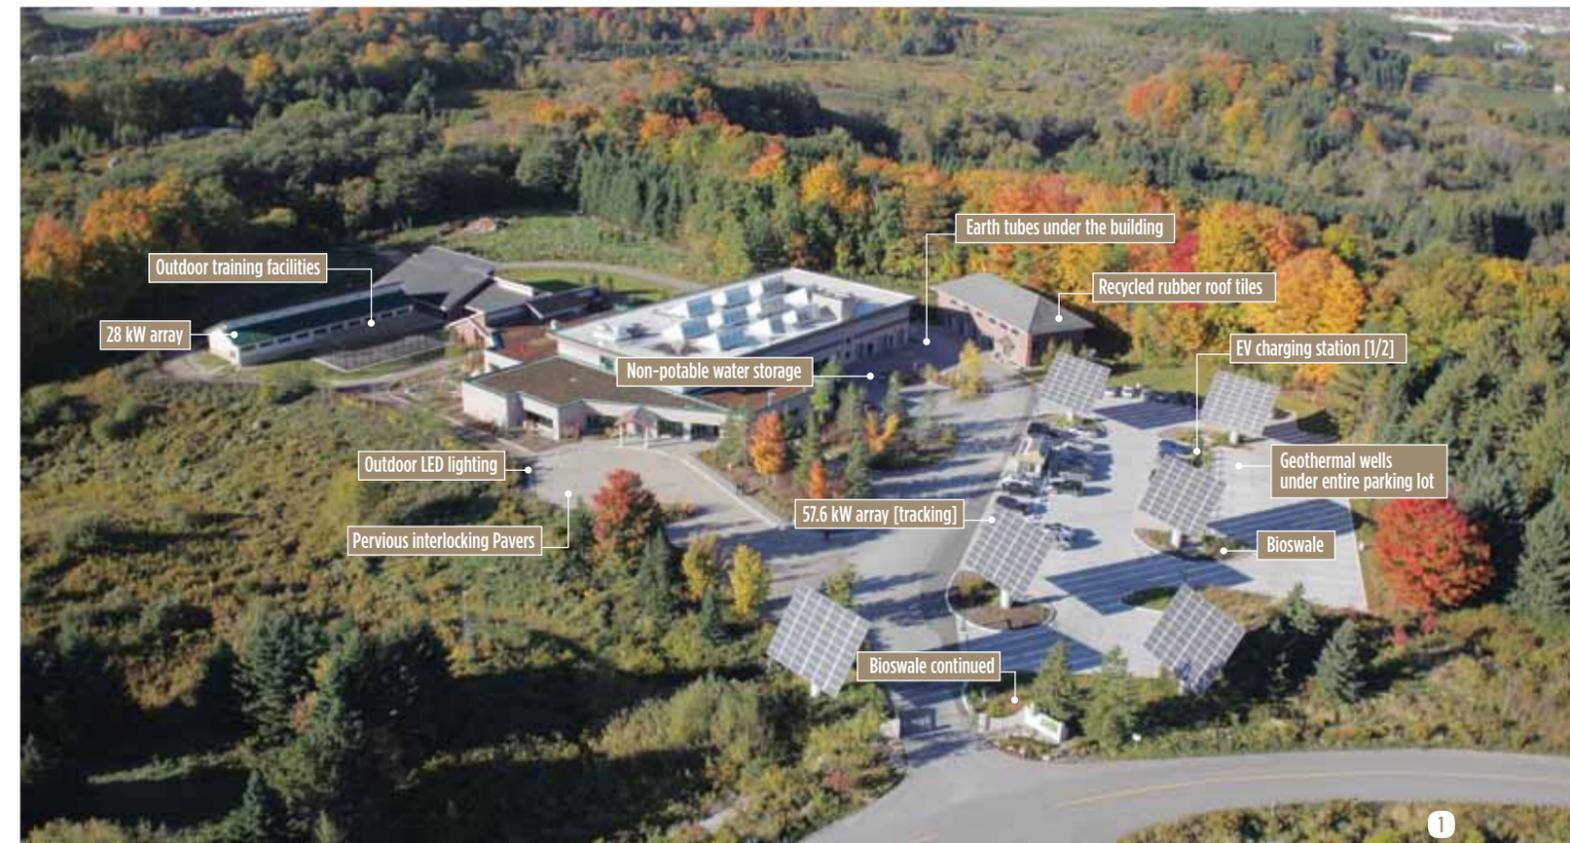
THE PROJECT SITE HAS FEATURES MANY ORIGINAL LOW-IMPACT DESIGN FEATURES AND UPDATES TO GENERATE AND CONSERVE ENERGY [1].

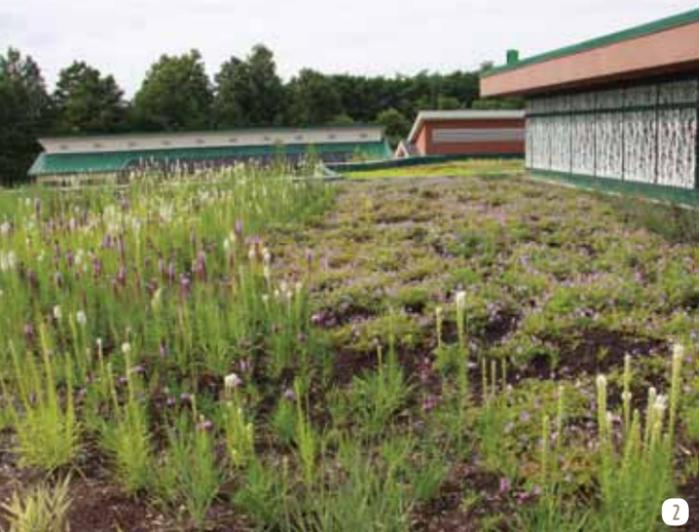
1,000 M² OF GREEN ROOF FEATURES 7.5-15 CM OF GROWING MEDIUM, AND MORE THAN JUST SEDUMS [2].

- Green and white roofs to reduce the heat island effect
- Bird strike prevention film [earning an innovation credit]
- Rain water harvesting with an on-site wastewater treatment system and waterless urinals
- Low lighting densities with natural day lighting and outside views

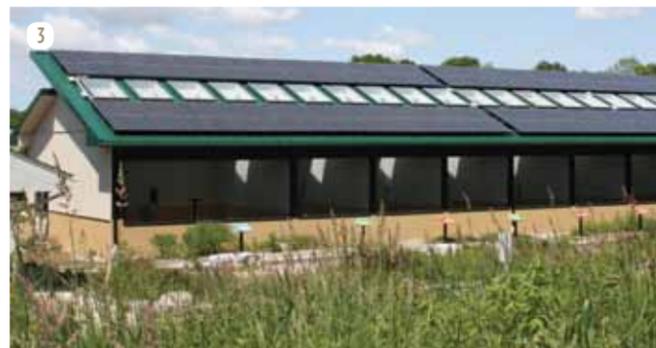
THE NATURALLY VENTILATED AND DAY LIT AVIARY FEATURES A 28KW PHOTOVOLTAIC ARRAY [3].

A couple of very visible changes also occurred on the grounds after the Gold certification. The building initially featured only thermal power generation in the form of solar thermal, but was designed to be solar-PV ready. In 2009 the first 28kW photovoltaic [PV] array was installed, and now generates 32,000 kWh per year, or enough to power the ERC's small data centre.
